OHIO RIVER BASIN
CHERRY RUN, JEFFERSON COUNTY

DOVERSPIKE NO. 1 DAM

NDI I.D. PA-01131

PHASE I INSPECTION REPORT
NATIONAL DAM INSPECTION PROGRAM

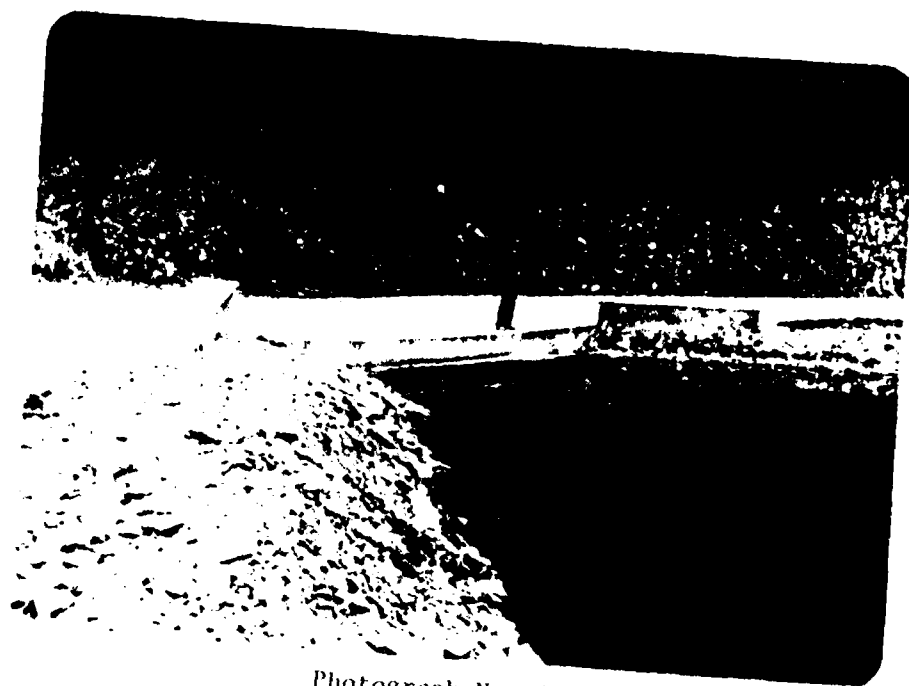
Photograph No. 3
Emergency spillway approach channel.

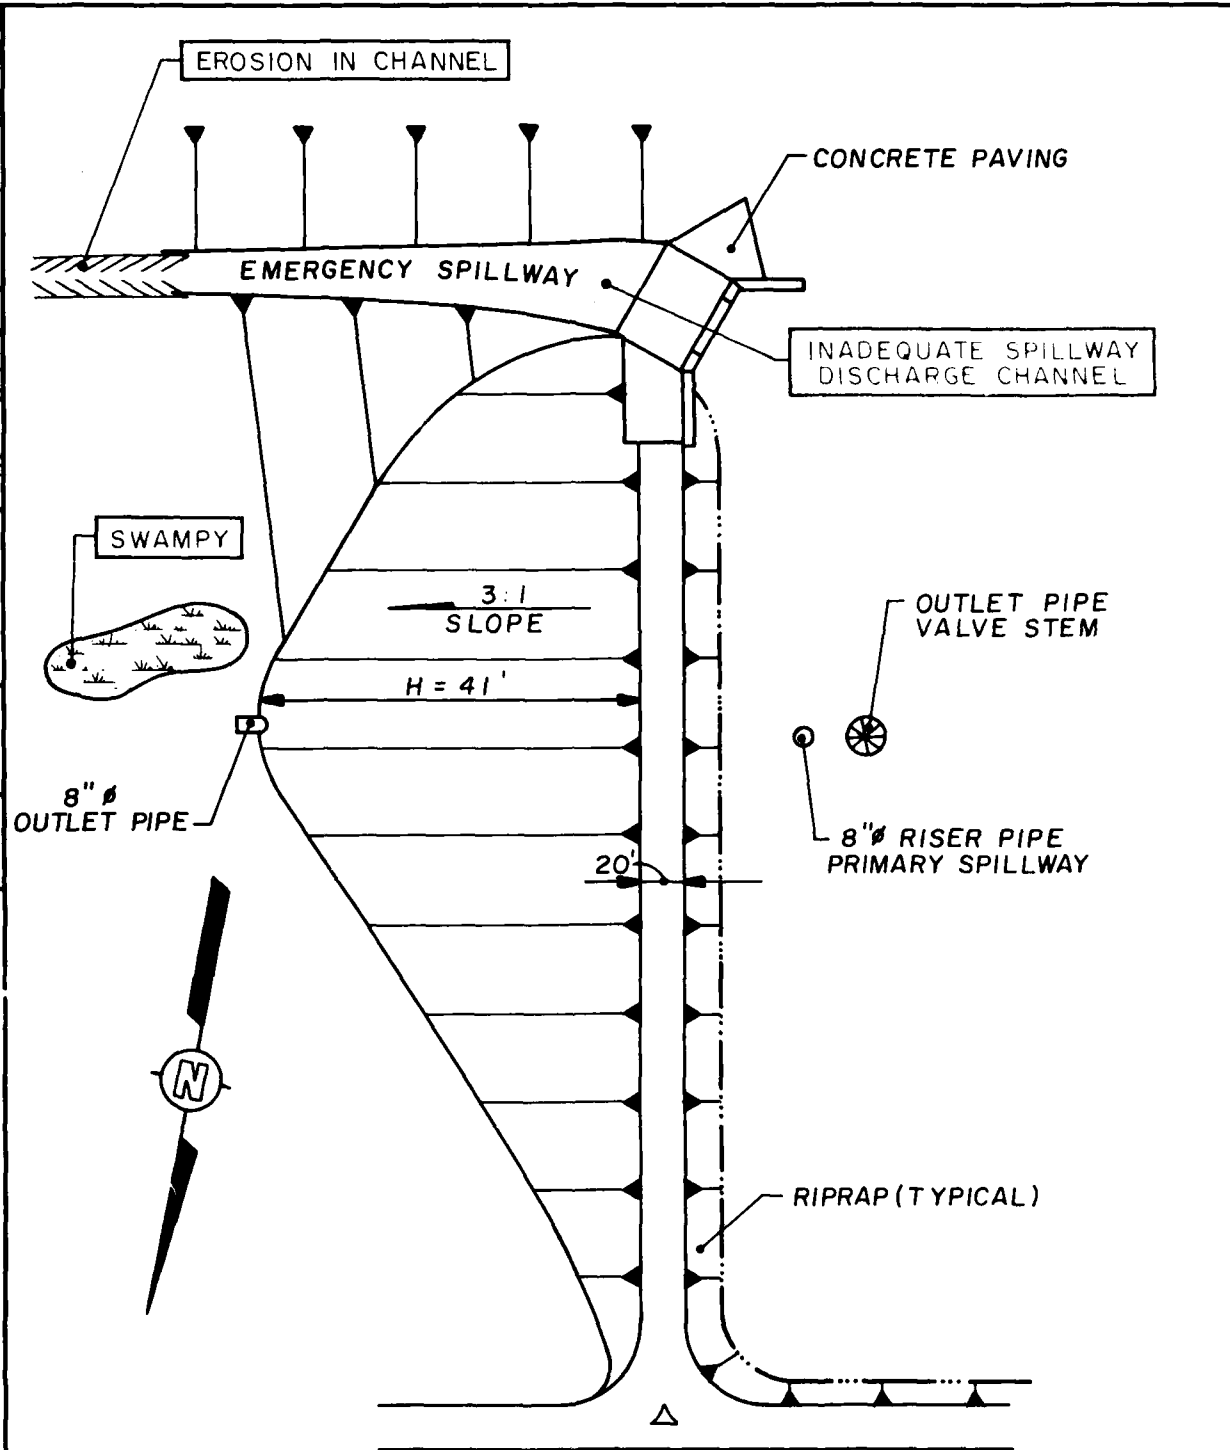
In general, the condition of the dam is considered to be good. A swampy area was located immediately below the downstream toe of the dam. However, no measurable seepage was found to be associated with this area. In its present extent and condition, this wet area is not considered to be a threat to the overall stability of the embankment at this time. However, periodic inspection would be required to insure that the conditions are not changing.

VISUAL EXAMINATION OF	OBSERVATIONS	REMARKS OR RECOMMENDATIONS
JUNCTION OF EMBANKMENT AND ABUTMENT, SPILLWAY AND DAM	No signs of distress.	
ANY NOTICEABLE SEEPAGE	A swampy area along the toe of the dam. See Plate 4 for location.	
STAFF GAGE AND RECORDER	None	
DRAINS	None

4.5 Evaluation. The maintenance condition of the dam is considered to be good. The embankment should be periodically inspected with emphasis on the swampy area along the downstream toe of the dam to determine that the conditions are not changing. The operational condition of the outlet pipe valve should be evaluated and necessary maintenance performed.

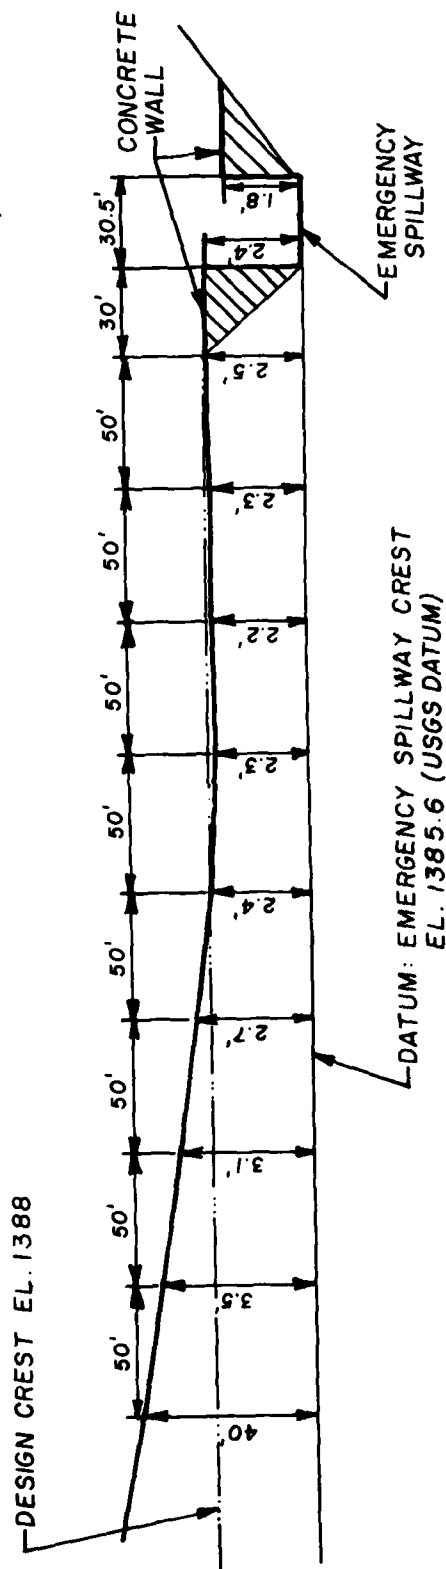
DAM CREST PROFILE (LOOKING DOWNSTREAM)

The crest of the dam was surveyed relative to the emergency spillway crest elevation and it was found to be generally at or above the design crest elevation. The dam crest profile is illustrated in Plate 5. The downstream slope was surveyed and found to be reasonably within the design slope of 3H to 1V.
